Reflective Cracking Testing Notes

Date: March 10, 2017

Project: Reflective Cracking Indoor Phase 5

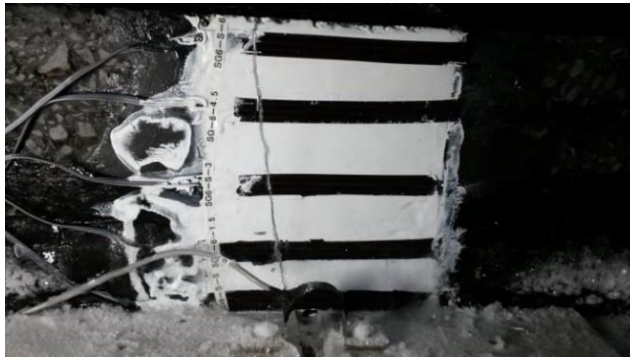
- Outer vertical edge:
 - The vertical edge is cracked. No visual change from yesterday was observed.
 - All the vertical edge surface gauges read open as shown in Figures 1 and 2.
- Joint surface area:
 - The South side surface crack has gone through SG5-S-6, SG4-S-6 and SG3-S-6.
 - SG5-S-6 and SG4-S-6 gauges read open. SG3-S-6 received crack damage but is not open. SG2-S-6 is still good.
 - The surface crack propagation is up to the 55” mark. SG2-S-6 is at the 57.5” mark of the 60” test section as shown in Figure 3.
- Inner vertical edge:
 - The lower half of the inner vertical edge is now cracked. SG1-S-0 is open. SG1-S-1.5 received crack damage. The crack stopped at SG1-S-3 as shown in Figure 4.

Figure 1. Outer vertical edge completely cracked.

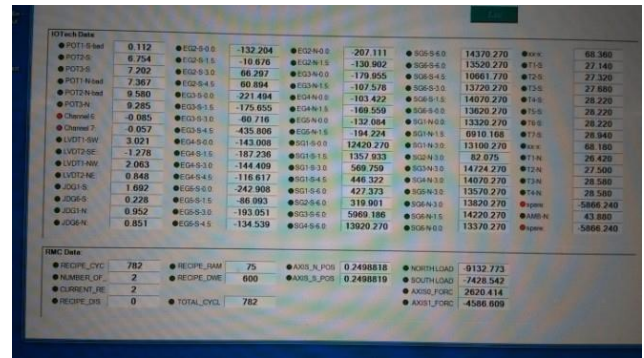
Figure 2. All vertical edge surface gauges are open.

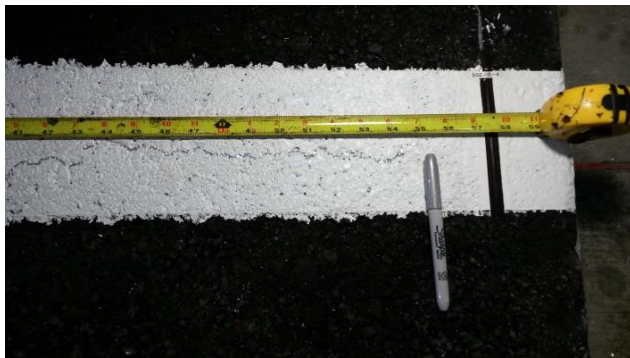
Figure 3. South side surface crack at 55" mark.

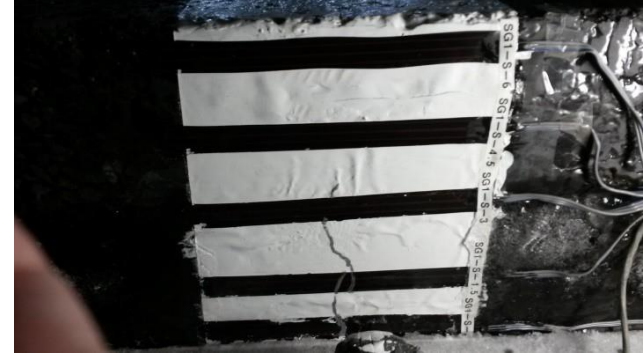
Figure 4. Lower half of the inner vertical edge crack.

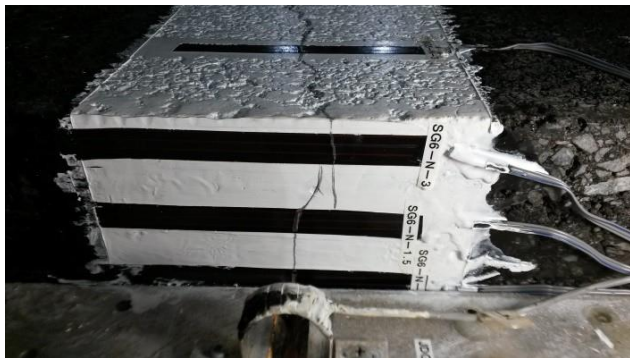
- Outer vertical edge:
 - The vertical edge is completely cracked as shown in Figure 5.
 - All vertical edge gauges are open.
 - No visual observation change.
- Joint surface area:
 - The North surface crack propagated 3.5” leaving it at the 50” mark.
 - A second new crack appeared coming in from the inner vertical edge. The crack is located on the lower left side of SG2-N-3 as shown in Figure 6.
- Inner vertical edge:
 - The North inner vertical edge is now cracked. The vertical crack propagated upward to the surface reaching SG2-N-3 as shown in Figure 7.
 - The North test section is not cracked between 50” and 58” of the 60” test section.
 - All the North side surface gauges are open but SG2-N-3.

Figure 5. North outer vertical edge crack.

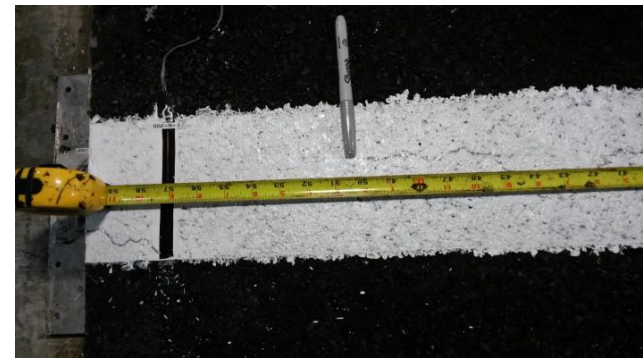
Figure 6. North surface crack at the 50" mark. Second surface crack on lower left of SG2-S-3 at 58" mark.

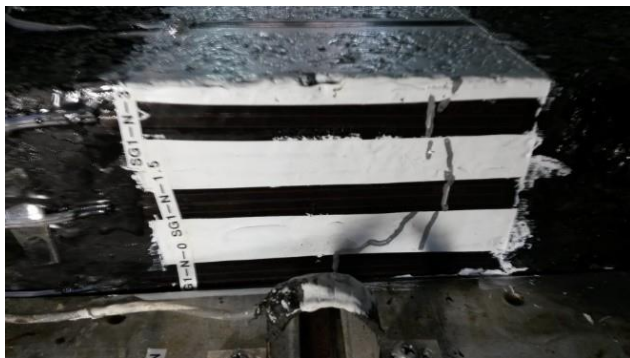
Figure 7. North inner vertical edge cracked. Surface gauges open.
